Your Building Inspection Report (PP- R)

ADDRESS: 1542 Maitland Vale Road, Lambs Valley

DATE/TIME OF INSPECTION: 27 November 2020, 10:00 AM

OUR REF: T249V33011

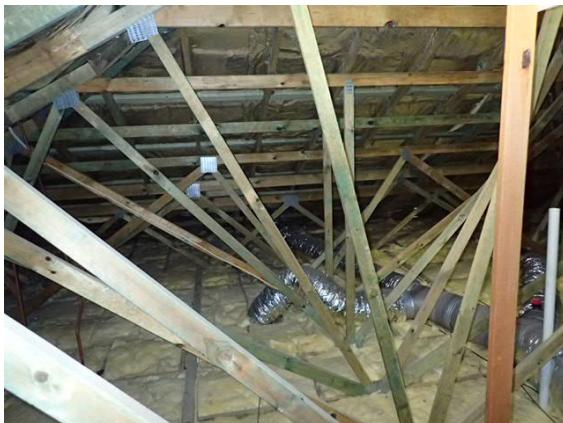
Treated pine roof frame and sarking blanket in place

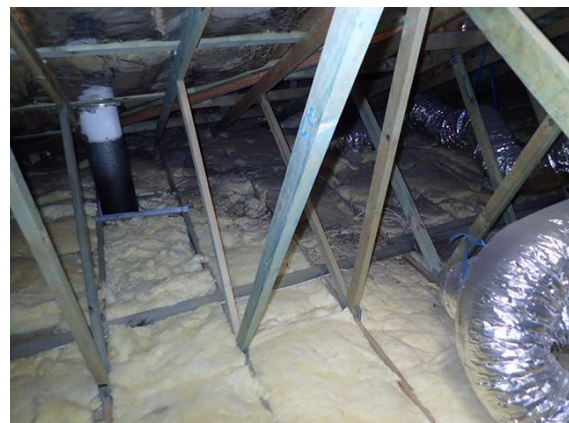
Yellow batts in place

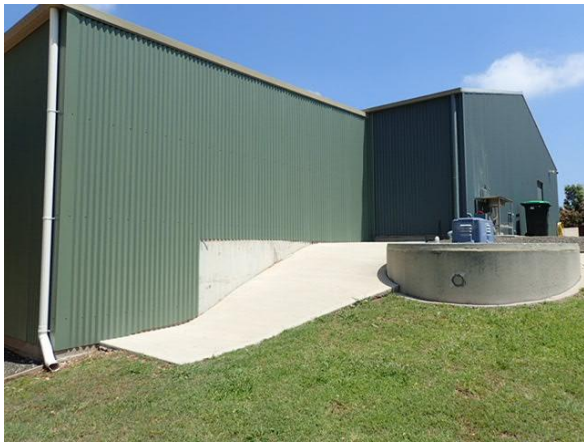
Metal garages in good order

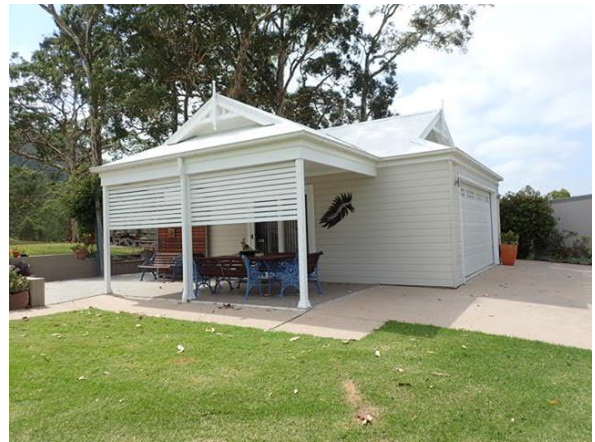
Granny flat in good order
