Your Building Inspection Report (PP- R)

ADDRESS: 1542 Maitland Vale Road, Lambs Valley

DATE/TIME OF INSPECTION: 27 November 2020, 10:00 AM

OUR REF: T249V33011

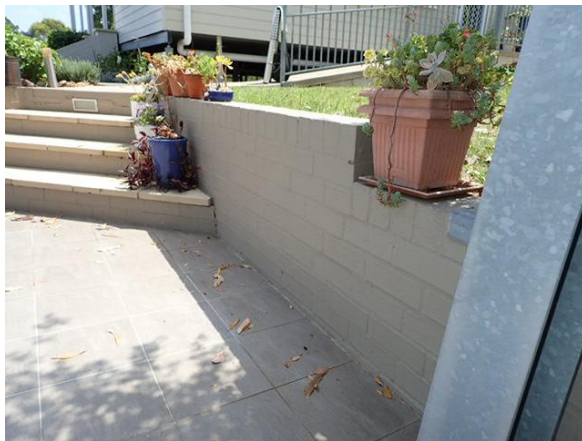
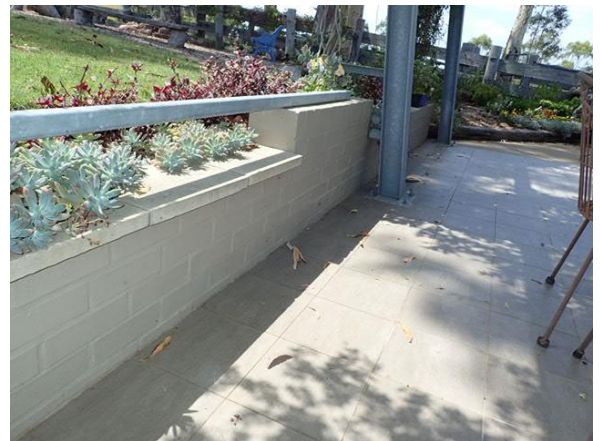
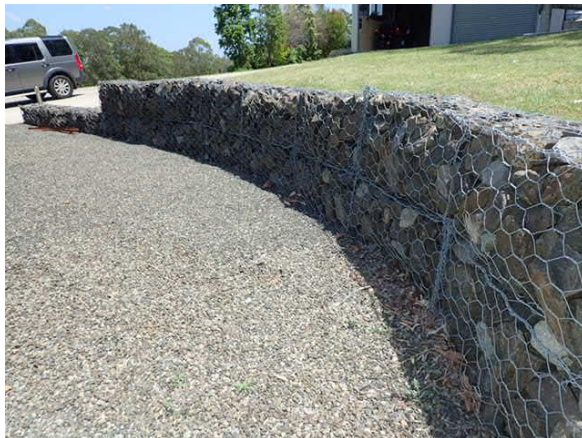
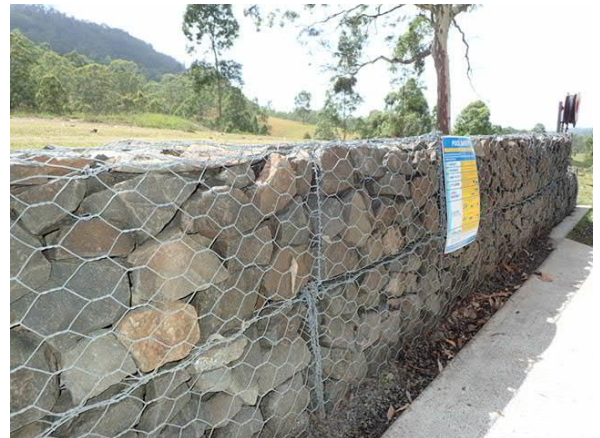
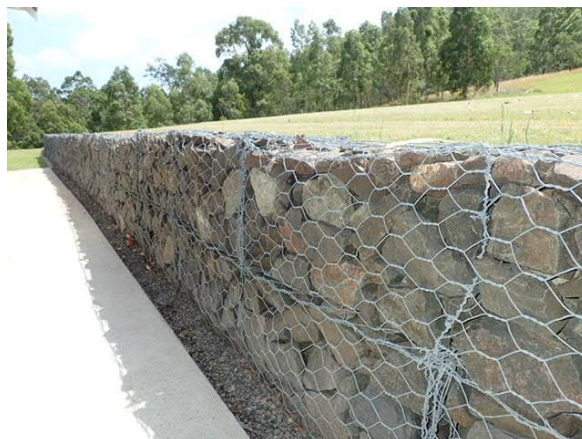
RETAINING WALLS / GARDEN WALLS

Installation: The low and high (ie over one metre) brick, stone and concrete walls appeared to be in reasonable condition, with normal wear and tear and no obvious major deterioration or leans to date. The walls are not supporting the main building but may require attention if required in due course. The necessary information to properly assess the retaining wall is not available and therefore the opinion of a Structural Engineer is essential. (See page 2 of **NOTES** at rear of report (B) **STANDARD NOTES, SN 3 - Watering Gardens** and page 4 of (C) **SPECIAL NOTES – RETAINING WALLS/GARDEN WALLS SP8 (a) – Retaining Walls**, see page 3 of **NOTES** at rear of report (B) **STANDARD NOTES SN 4- Cracks** and also very last page of this report: **Definitions- Structural Defect**)
